Geophysical Benthic Habitat Mapping of the Fal Estuary

Date: 26/06/2012
 Location: Fal Estuary
 Vessel: Xplorer
 Tide: 0922 UTC
 Wind: F2 SW
 Sea State: Flat

Investigation Aim: To carry out a habitat baseline survey to provide a report prior to the proposed dredging of a new channel in Falmouth Harbour.

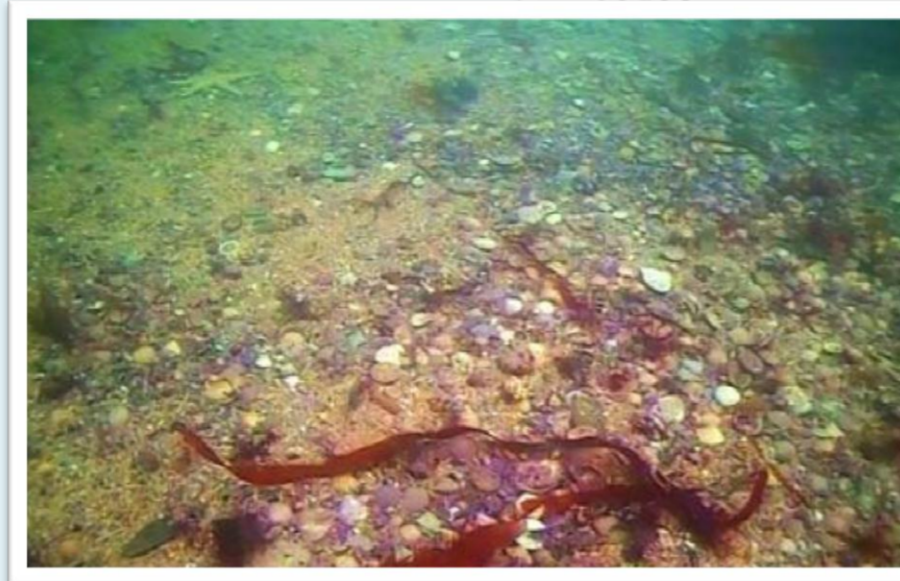
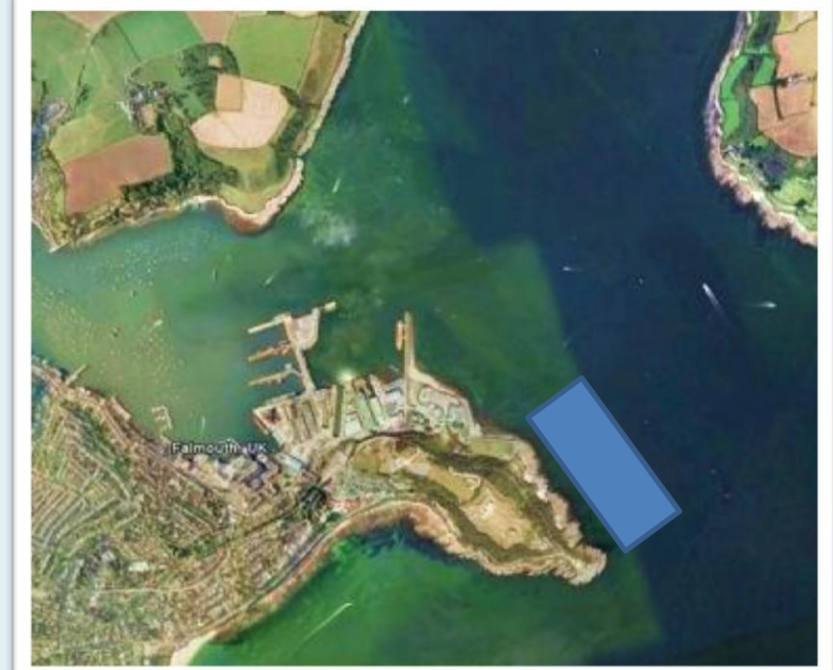
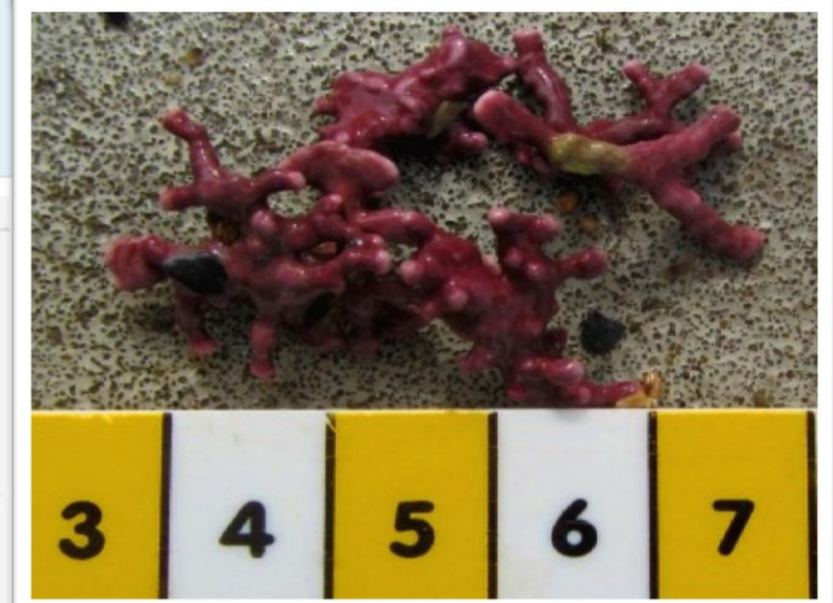
Boundary 1

This boundary was closest to the shore line, and consisted mainly of rocky outcrops of bedrock. An area on the scan shows a small artefact of boat wake, which corresponds to a passing boat, noted down on the trace. This area of the scan also shows some interference with the echo sounder also emitting from the boat.

interference with the echo sounder. A lighter return suggests finer sediment, getting coarser towards boundary 4.

Boundary 2

Possible rocky outcrop or coarse sediment patch.

Boundary 3

This boundary contains bedforms, which when analysed on the trace, have the height of small dunes at $H_s(m)=0.189m$, and trough length of ripples $L_s(m)=0.78m$. These values were achieved via standard correction equations applied to the trace. The bedforms are located to the North-east of the survey area, in track 5, and possibly induced as tidal forcing in this area is weak.

Boundary 4

Very fine sediment, verified by video footage which passed through this boundary. Return becomes very light, consistent darker lines could represent possible artefacts.

Boundary 5

Possible homogenous coarser sediment compared to other boundaries, represented by darker return. Sediment likely to become finer towards boundary 1,2 and 3, and rather sudden change towards boundary 5.

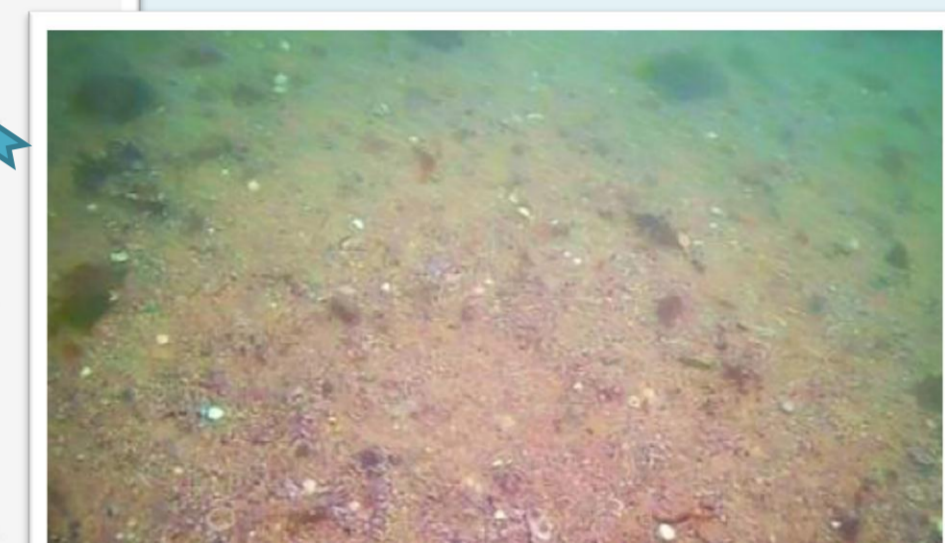
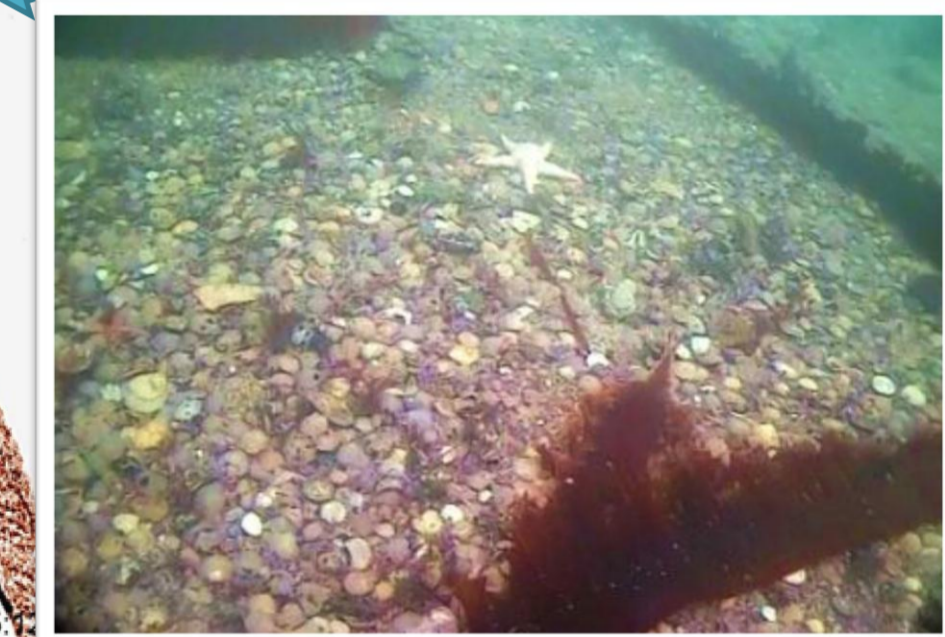
Screen shot from the video showing the differing bed types across boundaries 5 and 6.
